HISTORIC LANDSCAPE REPORT
PRESERVATION PLAN AND MANAGEMENT PROPOSAL

WASHINGTON PARK, ALBANY, NEW YORK

WASHINGTON PARK CONSERVANCY AND CITY OF ALBANY

May, 1989

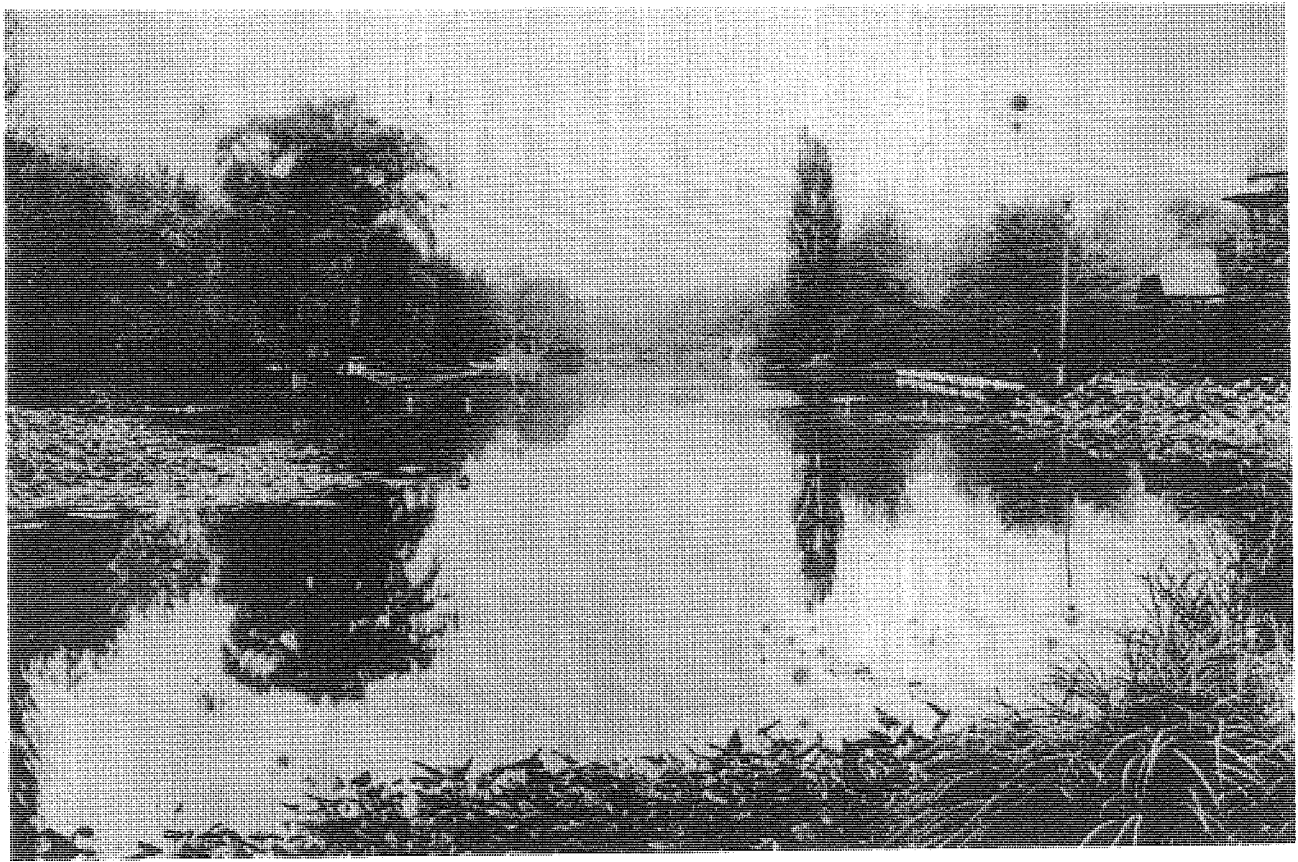
Top: Early view of the Lake with the original Lake House, shows Aquatic Gardens with water lilies, lotus and other aquatic plants, note boats on shoreline, picturesque Willow and Poplar trees at Lake edge, c. 1890. AI-DPR

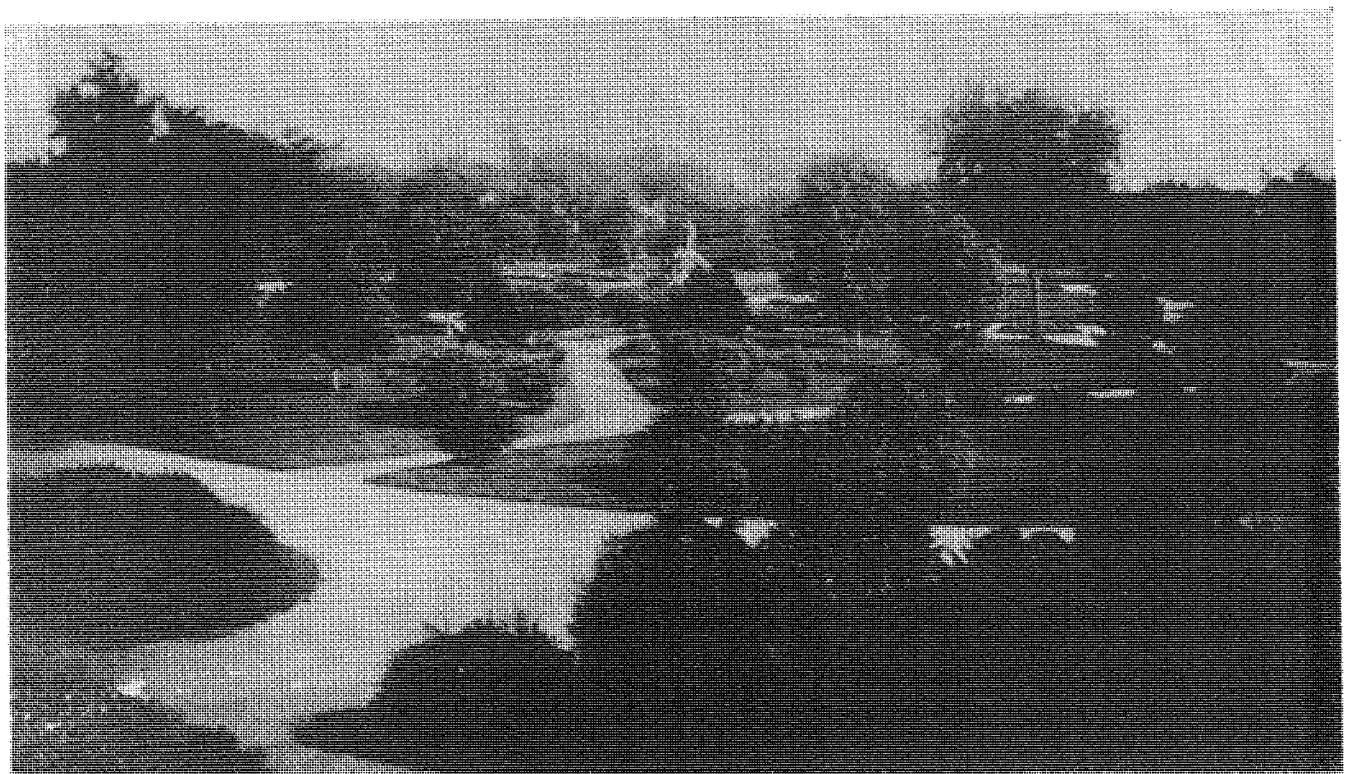
Bottom: View from Elm Grove Outlook toward Moses Fountain shows character of park landscape, c. 1900. NYS-L

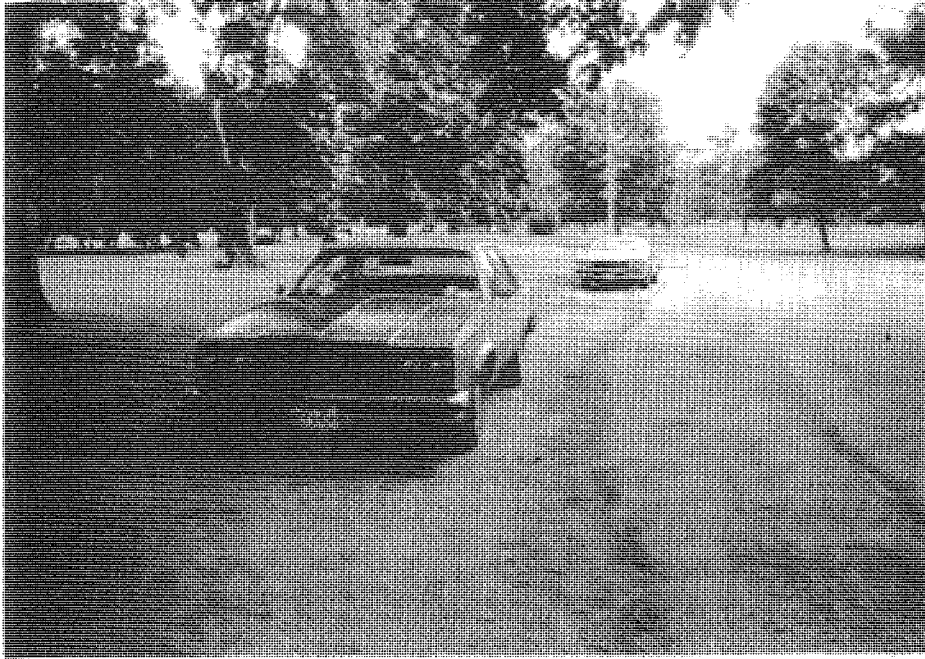
Top: Park drive without curbs, shows vehicular compaction damage ten feet from road surface, 1988.

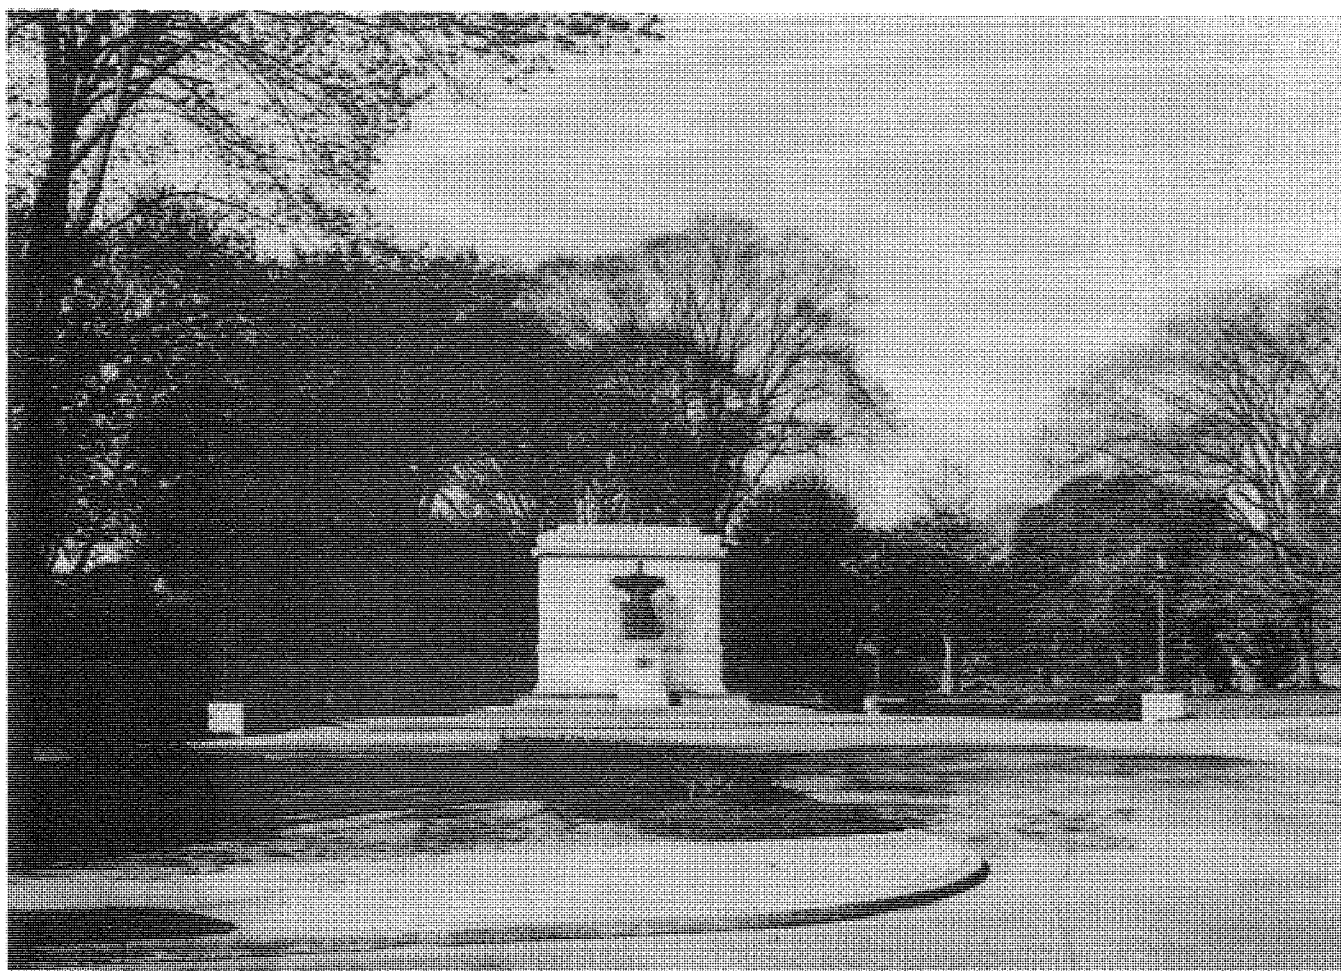
Bottom: View of Soldiers and Sailors Memorial from State Street, unveiled in 1912, shows open, paved space, benches, four decorative light posts on stone plinths and Mall Elms as a frame behind the memorial. WPC

The Soldiers and Sailors Memorial is a highly important focal element in the park. It functions as a focal object and visual terminus for the formal Mall. The monument itself is granite, marble and bronze. It was restored in 1986-87 and is in very good condition. A new pavement panel and four decorative lights form a frame around the monument. Long wooden benches were formerly placed at the corners of the pavement and are visible in early photographs. Historic photographs and postcard views show the memorial backed by towering elms.

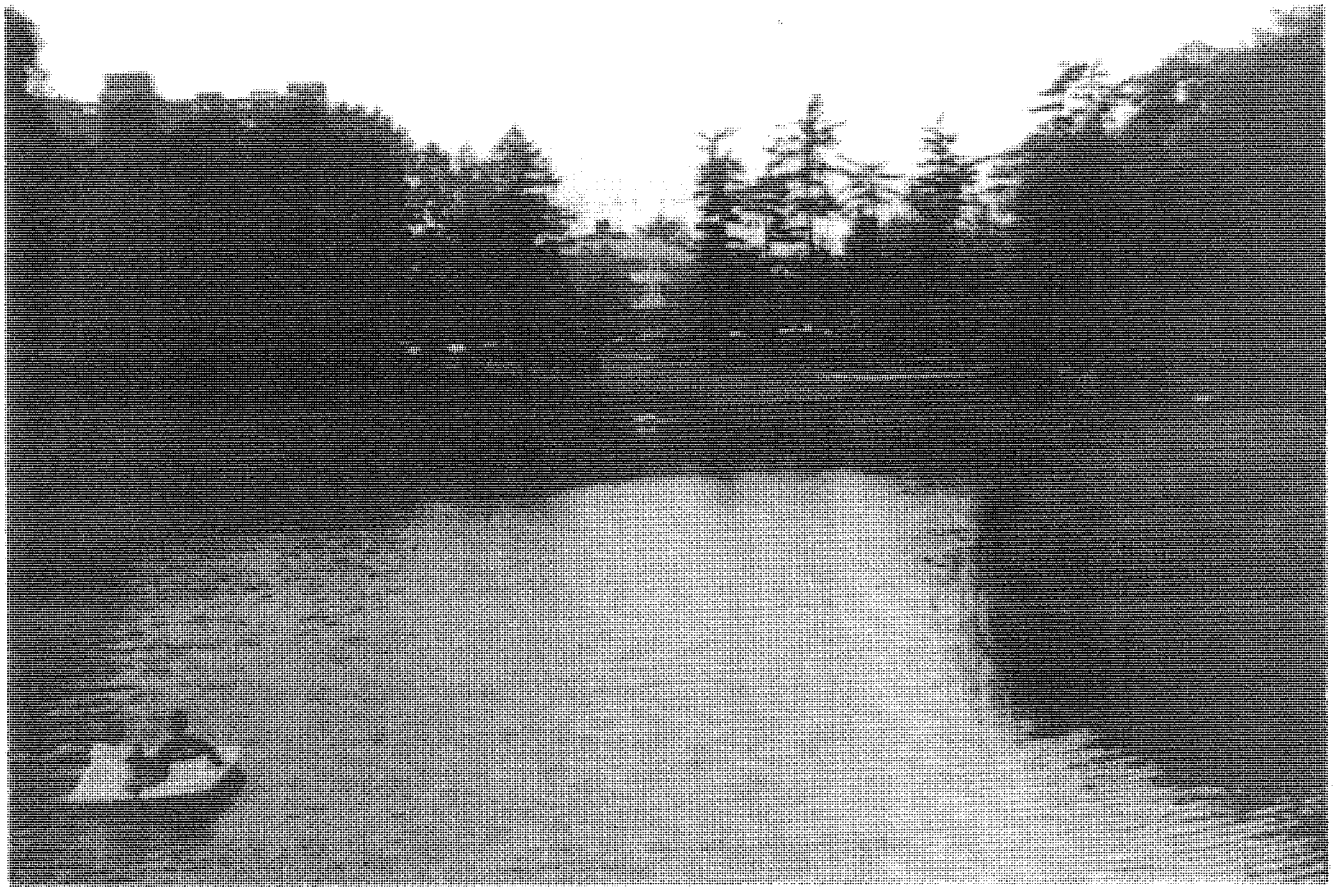
Top: Paddle boating on the Lake, note Phragmites mass on the right and Larch grove on left, 1988. K/L
 Bottom: Ice Skating on the Lake, note pedestrian light pole on scenic outlook, and arched facade of Lake House, January 1935. AI-CN

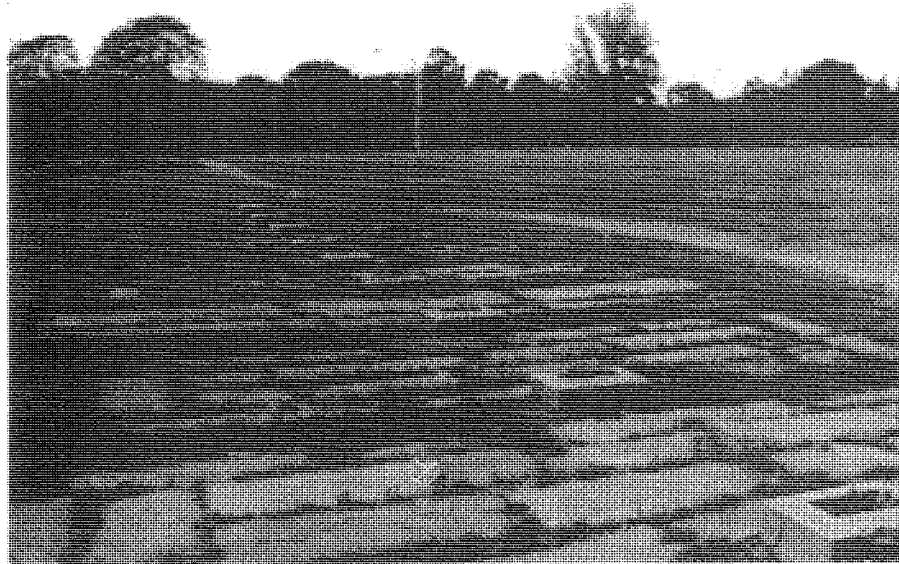
Top: Flagstone surface and post foundations for former Wooden Swings in foreground, open expanse of former Croquet Lawn in background, 1988. K/L
 Bottom: Detail of Wooden Swings, with small Drinking Fountain Shelter in background, 1944. AI-DPR

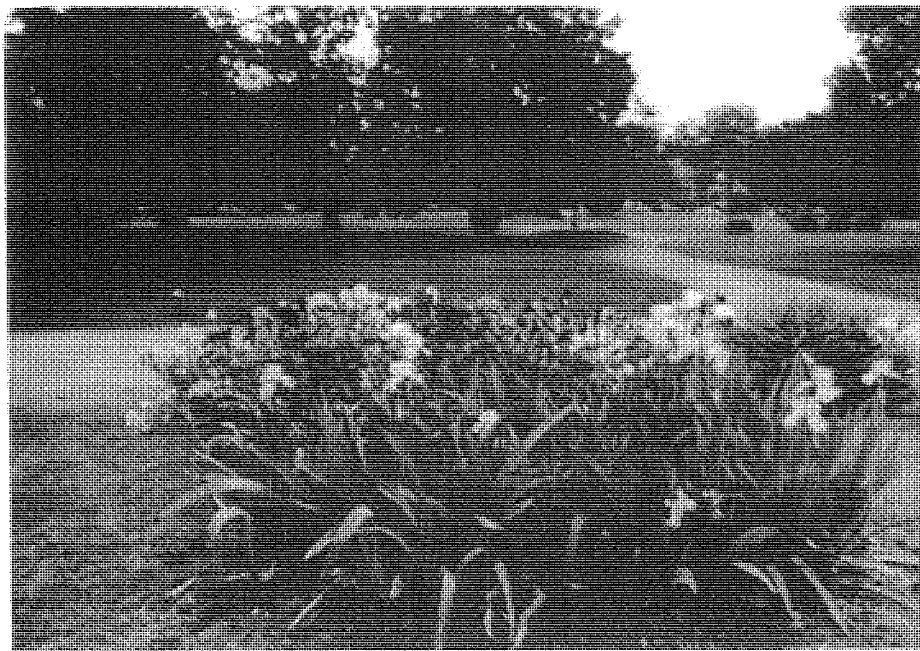
Top: German Bearded Iris garden at Croquet Lawn stairs, an attractive, new planting in a location that lacks historic precedent, 1988. K/L

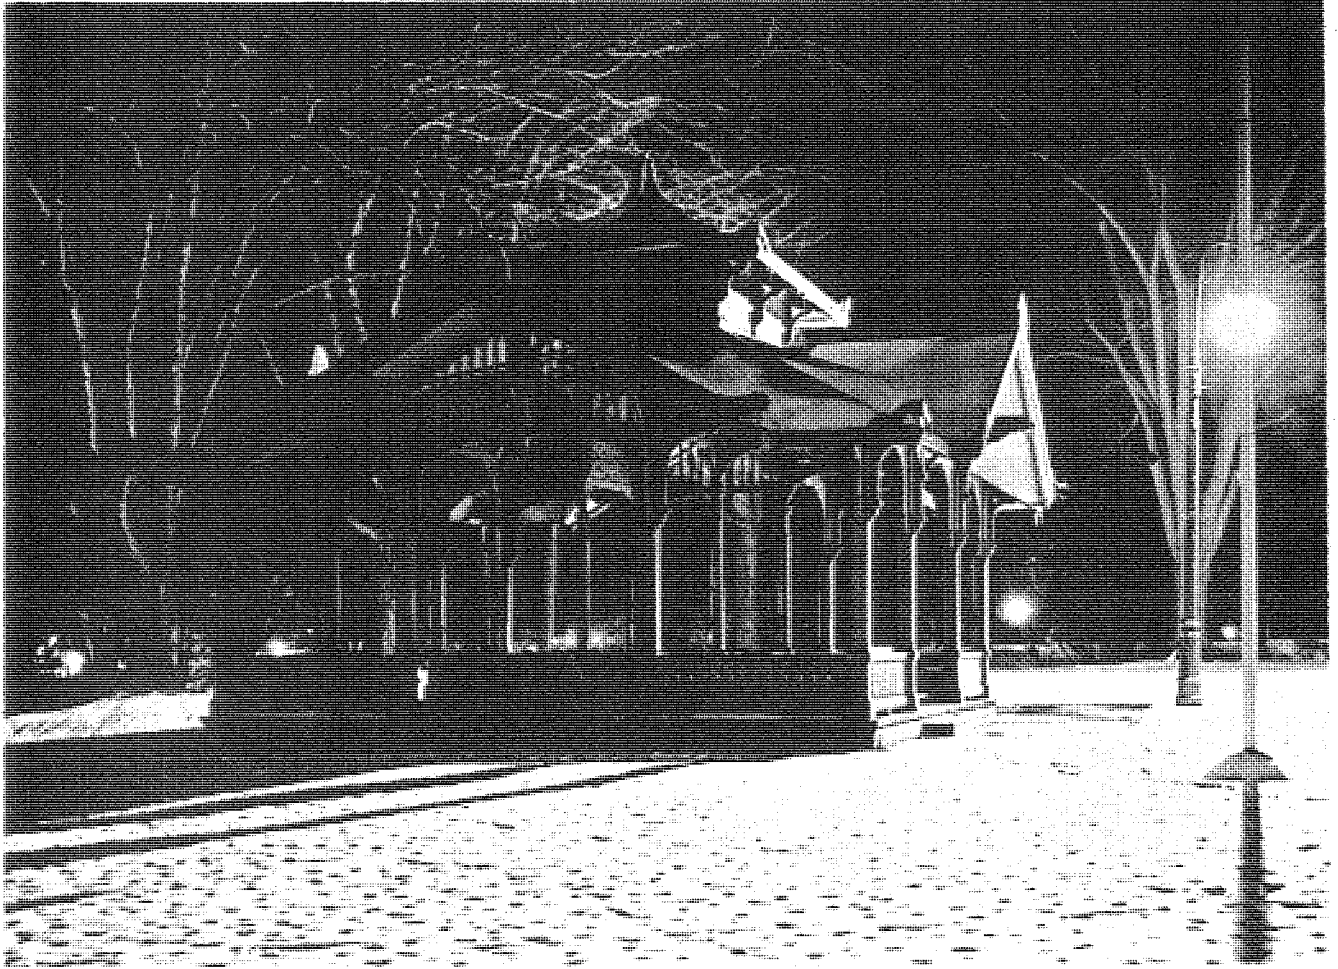
Picturesque view of ornate Croquet Shelter at night, use of this structure as a model for a replacement or new greenhouse facility is recommended, December, 1938. AI-CN
